## THE EFFECT OF RESIDUAL STRESSES AND EXTERNAL EFFECTS ON THE FRACTURE BEHAVIOUR OF PVC PIPES

Kiwa Technology  
Apeldoorn, the Netherlands

### SHORT SUMMARY

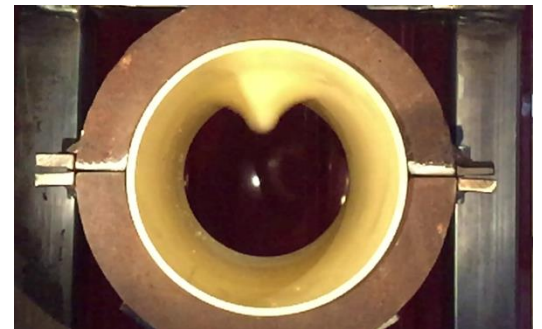
Figure 3. Deformation of the entire PVC-U segment is prevented by a thick steel jacket pipe. Brittle failure is inevitable (this has not yet occurred in this frame). The PVC can deform locally around the striker.

When elastic pipe deformation was completely eliminated by the thick steel jacket pipe, deformation was very localised (Figure 3). Failure occurred very locally around the striker (Figure 6), resulting primarily in the testing of the material rather than the complete deformation of the pipe.

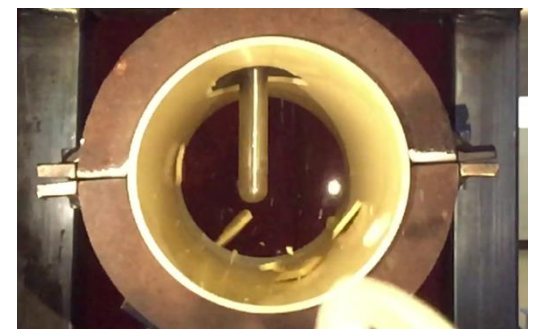
Figure 6. A few frames after Figure 3. There is local brittle failure only.

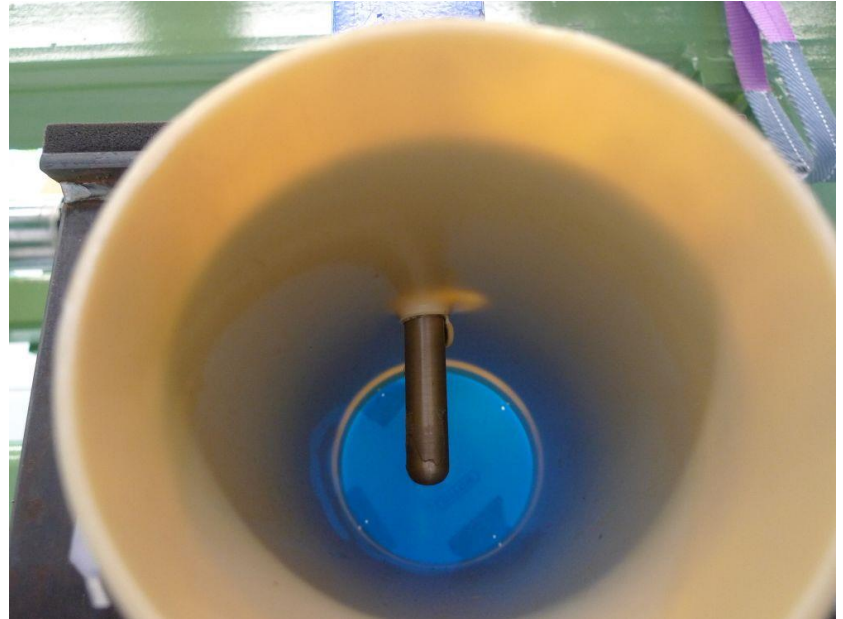
Figure 8. A different PVC-U pipe failed in a ductile way, when the test parameters were exactly the same as in Figure 7.

It is clear that the clamping method plays a major role. However, the quality of the material should not be underestimated as a factor. In the initial tests with the selected PVC-U pipes, only brittle fractures were observed when the segments were supported by the repair clamp. However, in a few exploratory tests using a different PVC-U pipe, this pipe failed in a ductile way when the test parameters were identical (compare Figure 7 and Figure 8). In this case, the difference in failure behaviour upon impact was caused only by a difference in the quality of the material. This result obviously concurs with practice, where some pipes shatter and other pipes do not fail at all in similar conditions.

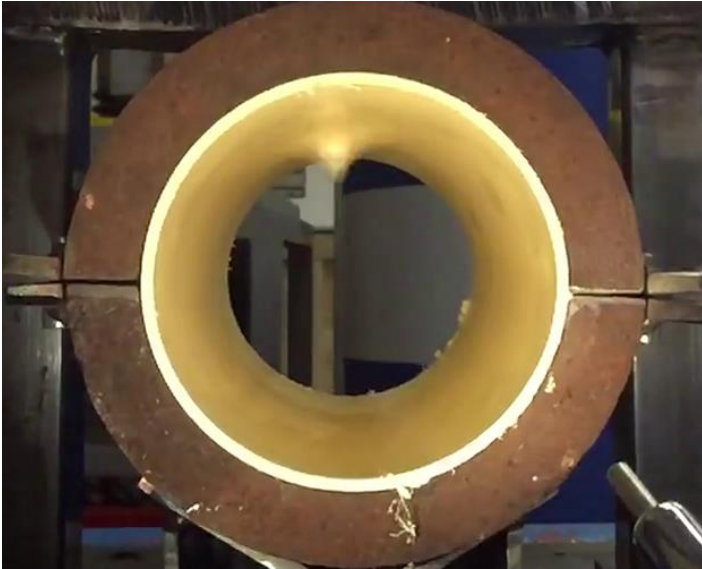
Figure 9. Still made with a high-speed camera just before failure. There is hardly any local deformation in the PVC-U pipe segment around the small striker (compare with Figure 3).

The striker diameter was therefore reduced from 18.75 mm to 8 mm. In this case, it was possible to induce ductile failure in the selected PVC-U pipe (Figure 10) because the stresses are absorbed by a much smaller surface area. This was also observed in the extent of local deformation just before failure, which was much less when the 8 mm striker was used by comparison with the original striker (compare Figure 9 with Figure 3).

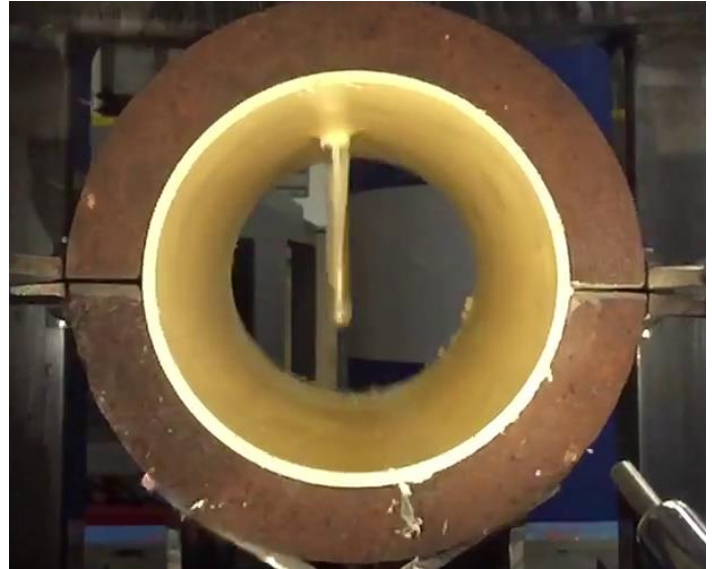
Figure 10. The PVC-U pipe segment fails in a ductile way when a smaller striker is used (compare with Figure 6).

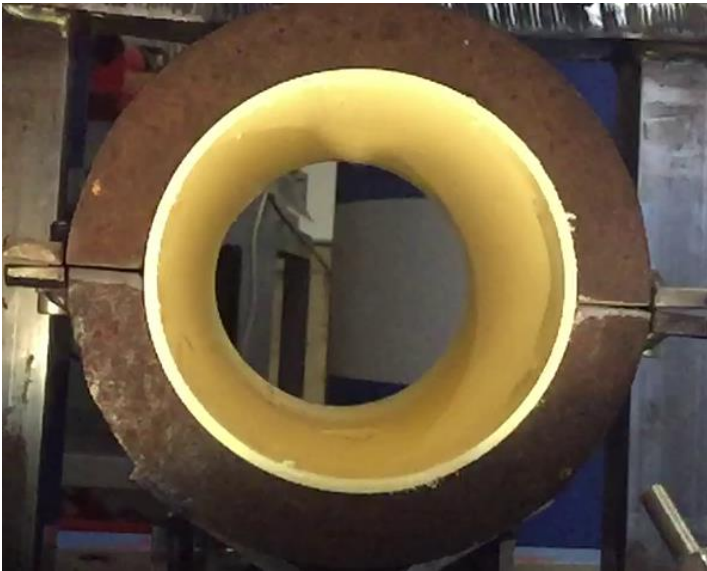
Figure 11. Still made with a high-speed camera just before failure. As at room temperature, there is hardly any local deformation of the PVC-U pipe segment at 5 °C around the small striker (Figure 9).

The selected PVC-U pipe failed in a brittle way at about 5 °C using the smaller striker (Figure 11 and Figure 12). This means that the brittle-ductile transition temperature can be determined for pipes with high residual stresses and low residual stresses (see below).

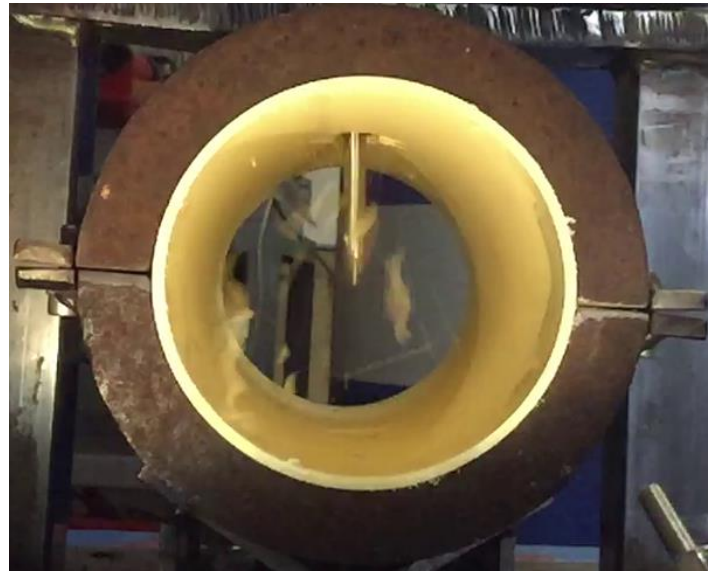
Figure 12. The PVC-U pipe segment fails in a brittle way when a smaller striker is used at 5 °C (compare with Figure 10).
